# PHASE I ENVIRONMENTAL SITE ASSESSMENT

## INGALLS PROPERTY SAN DIEGO, CALIFORNIA

**GEOCON PROJECT NO. 09712-06-01**

**AUGUST 15, 2006**

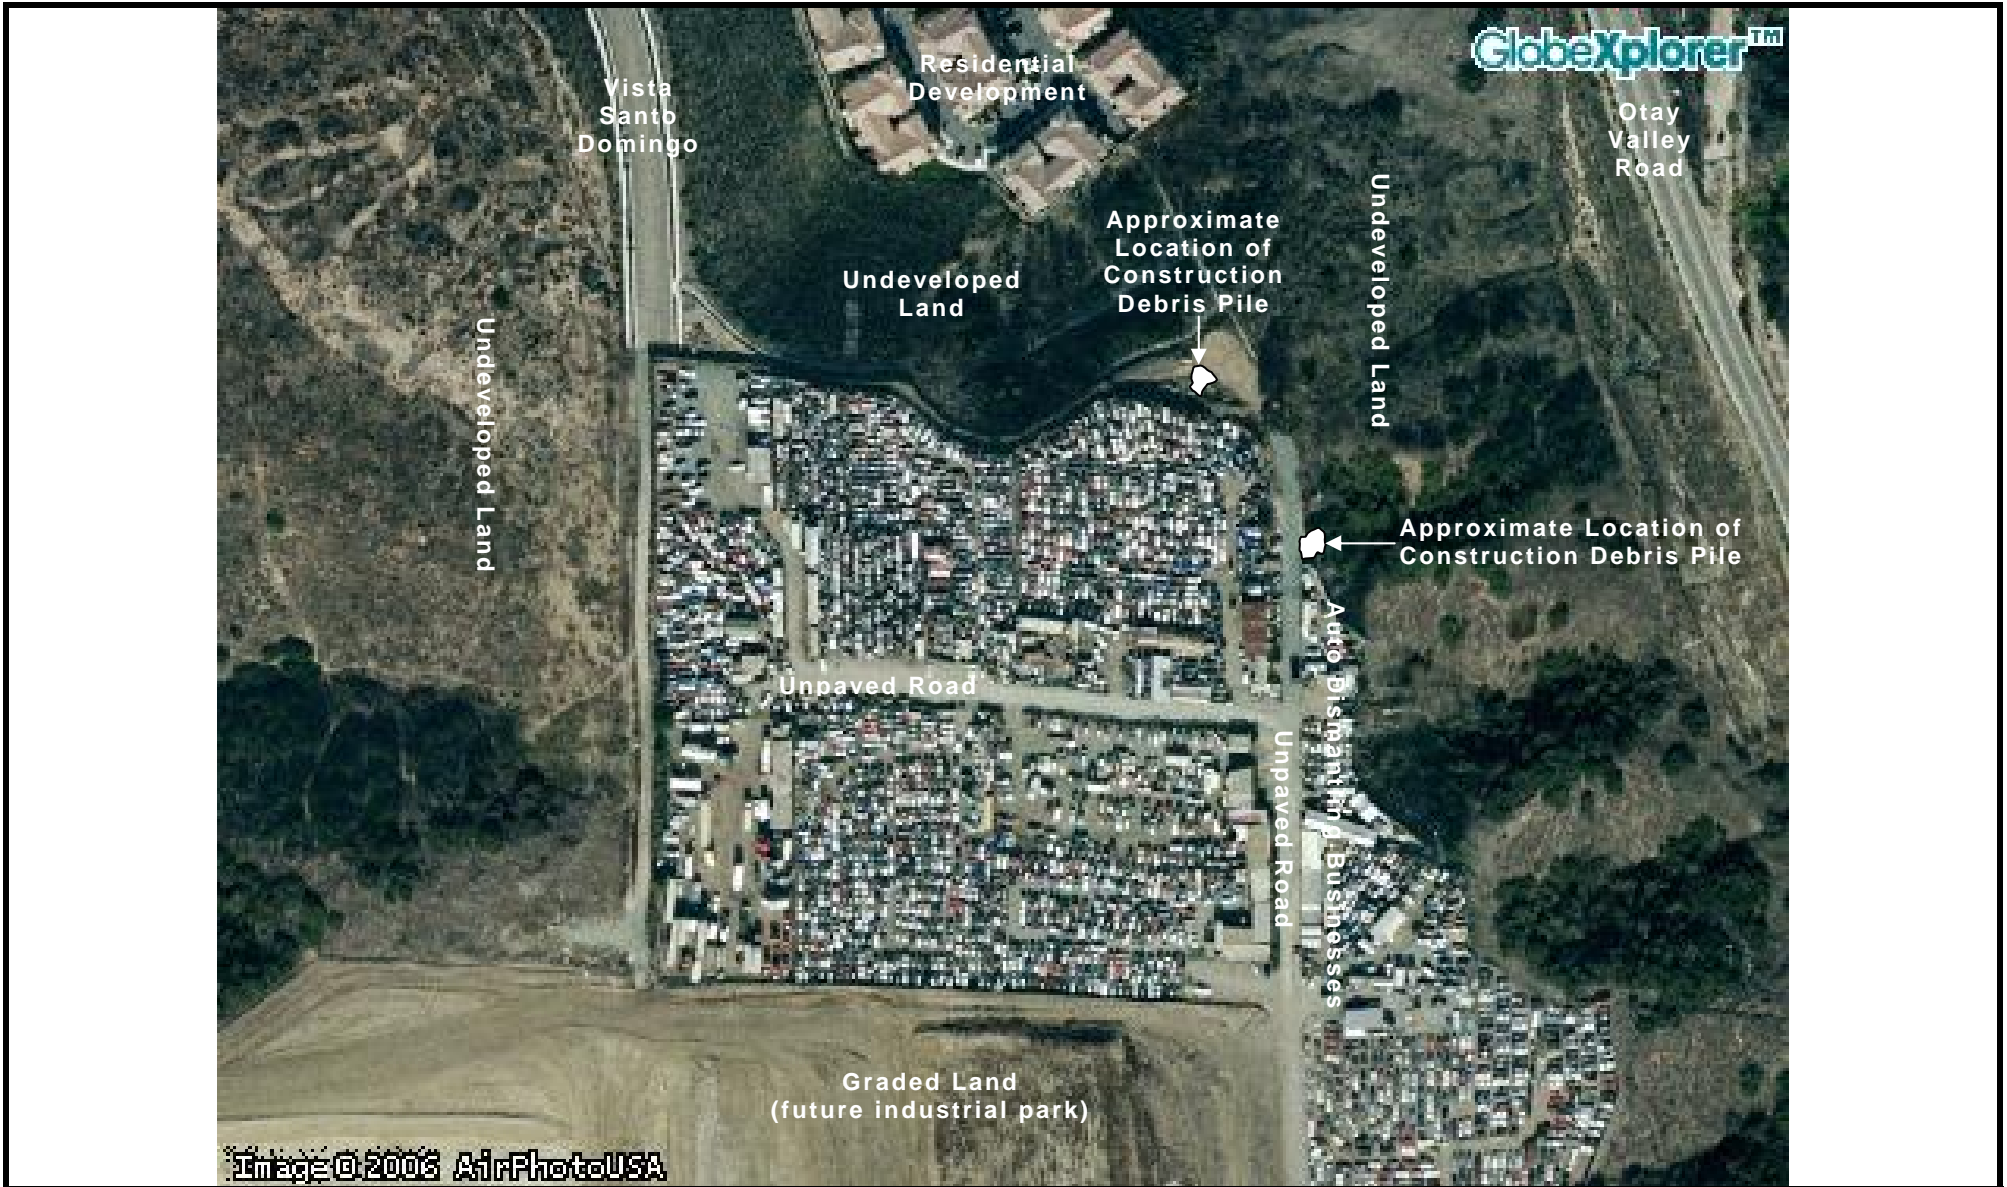
DATE: 8-15-2006	PROJECT NO. 09712-06-01	FIG. 2
-----------------	-------------------------	--------

A Site Plan illustrating the noted site features is included as Figure 2. Photographs taken during the site reconnaissance are presented as Appendix B.

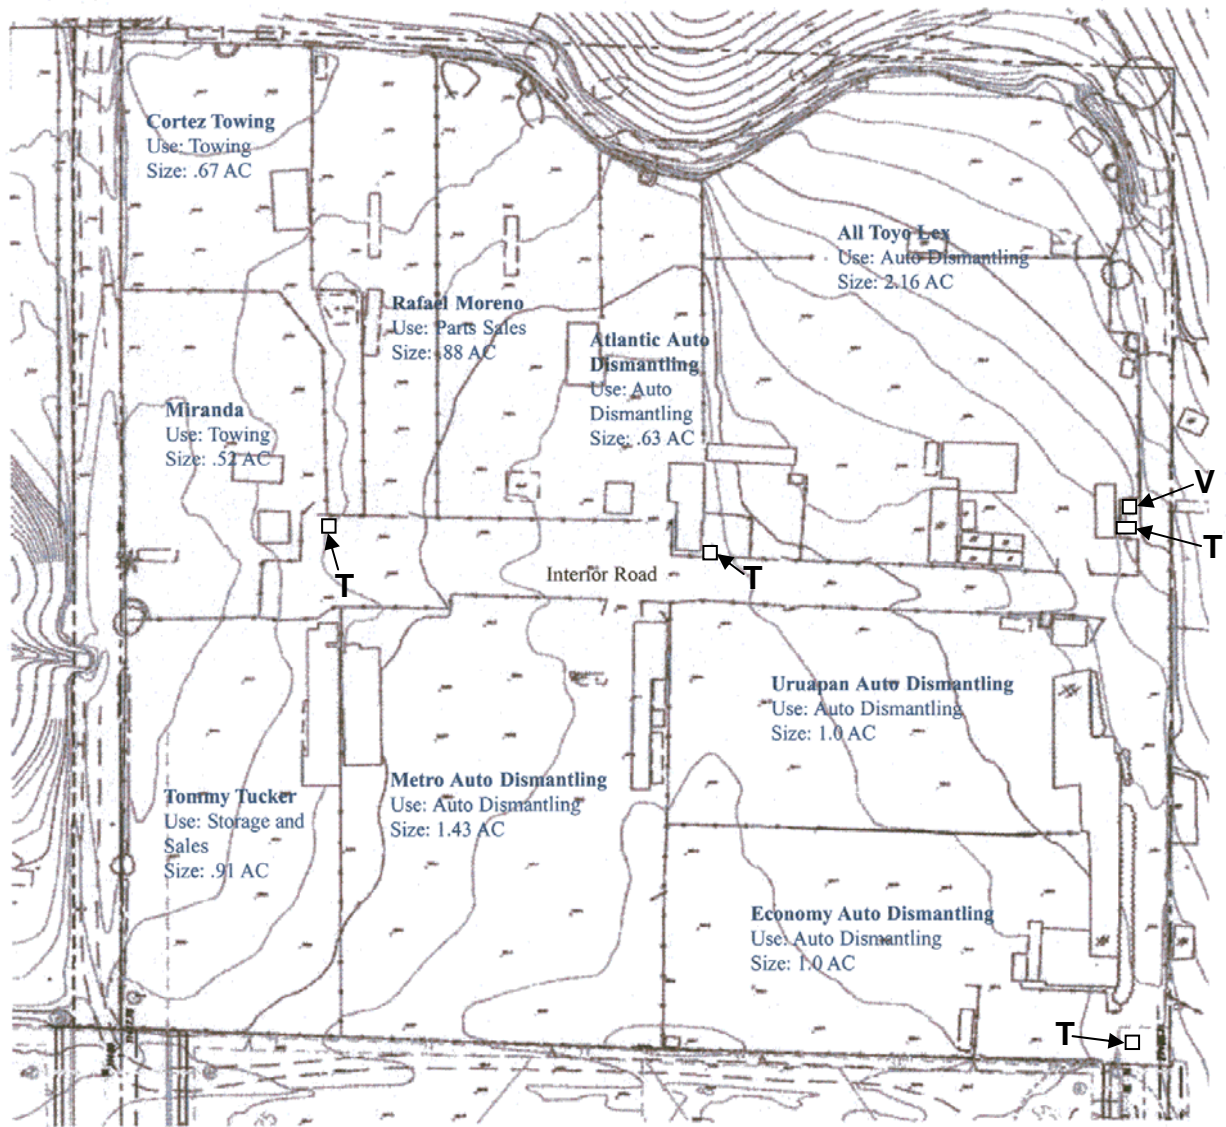
DATE: 8-15-2006	PROJECT NO. 09712-06-01	FIG. 3
-----------------	-------------------------	--------

Four pad-mounted electrical transformers, owned and maintained by San Diego Gas & Electric Company (SDG&E), were observed at the Site during the Site reconnaissance (Figure 3). The transformers appeared to be in good condition, with no visual evidence of spills or leaks. See Section 5.3 for information regarding the polychlorinated biphenyl (PCB) content of the transformers.

During the site reconnaissance, four pad-mounted electrical transformers were observed at the Site. Three of the transformers are located in the central portion of the Site, adjacent to the unpaved roadway, and the fourth transformer is located in the southeast corner of the Site (Figure 3). Documented discussions with SDG&E representatives regarding transformers indicate that SDG&E has never specified PCB-containing transformers for its electrical distribution system. However, SDG&E has determined that some older (pre-1980s) mineral transformers were inadvertently contaminated with PCBs by the manufacturer. Based on a statistical sampling and testing program reportedly performed by SDG&E, it is unlikely that transformers found within its service area contain PCBs.

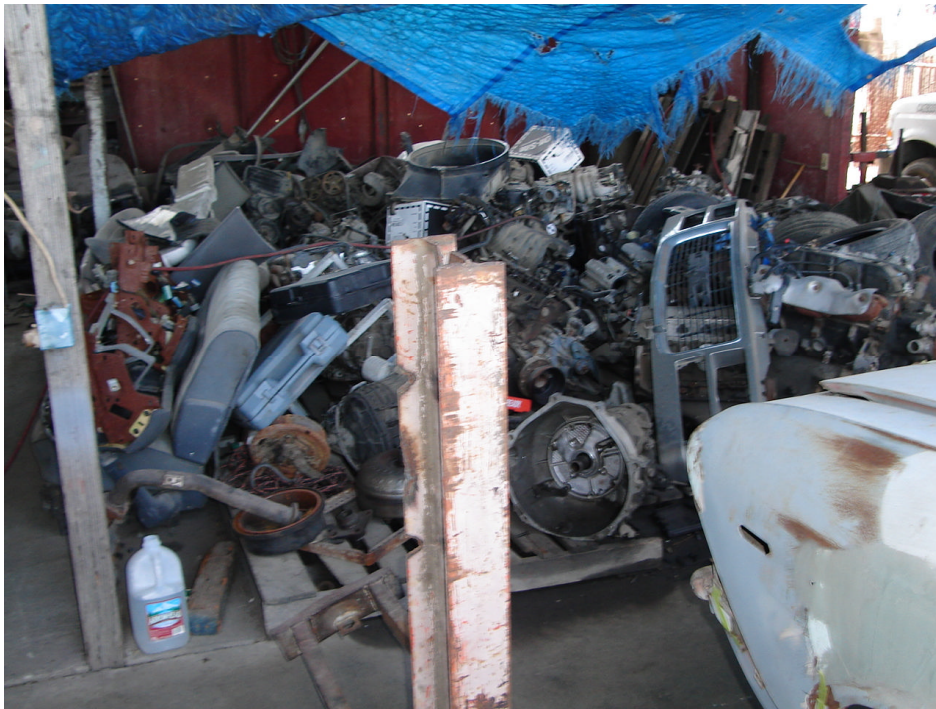
Significant staining was noted on the concrete floor in the auto dismantling area at Uruapan Auto Dismantling. The staining appeared to be from draining, over an extended period of time, of automobile fluids associated with used automobile engines stored in this area. Because of the large number of automobile parts stored in the area, it was not possible to assess the extent of the staining or the condition of the concrete pavement in this area.

**Photograph #7**  
**View of auto dismantling area at Uruapan Auto Dismantling in east-central portion of Site; note staining on concrete floor in center of photo.**

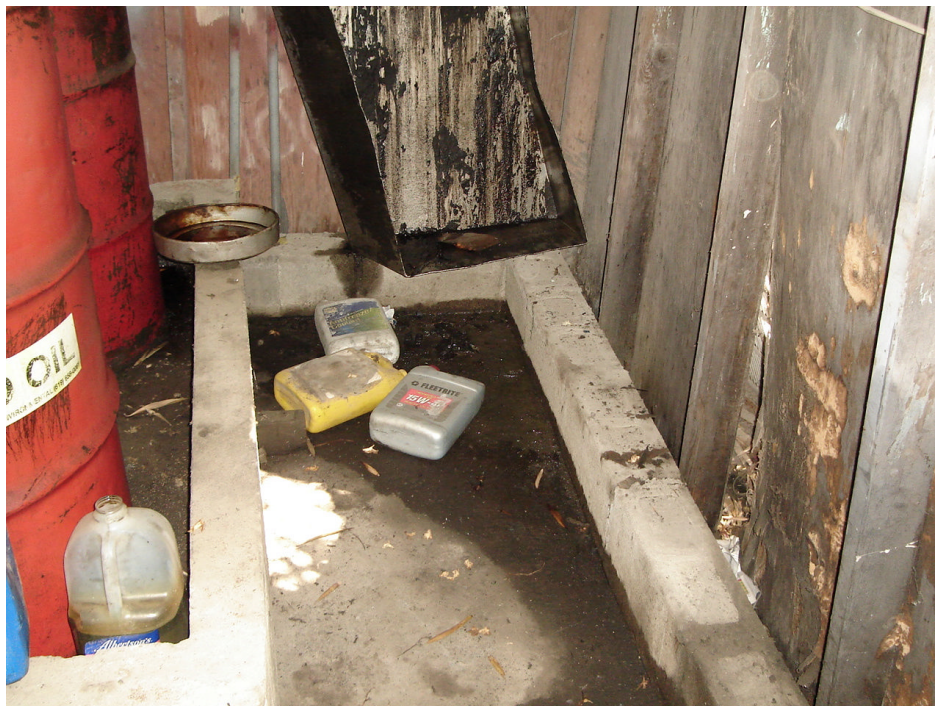
A heavy oily stain was observed within the secondary containment area and in several areas on the concrete floor adjacent to the secondary containment area in the hazardous waste storage shed at Uruapan Auto Dismantling. The staining appeared to be from overspilling from the hazardous waste drums and plastic containers observed in this area. The concrete floor in the shed (outside the secondary containment) appeared to be intact, with no evidence of significant cracks observed. Because of the large volume of drums and other items stored within the secondary containment, it was not possible to observe the condition of the floor within the secondary containment.

**Photograph #9**  
**View of oily stain on concrete floor in shed containing waste oil and waste anti-freeze at Uruapan Auto Dismantling.**

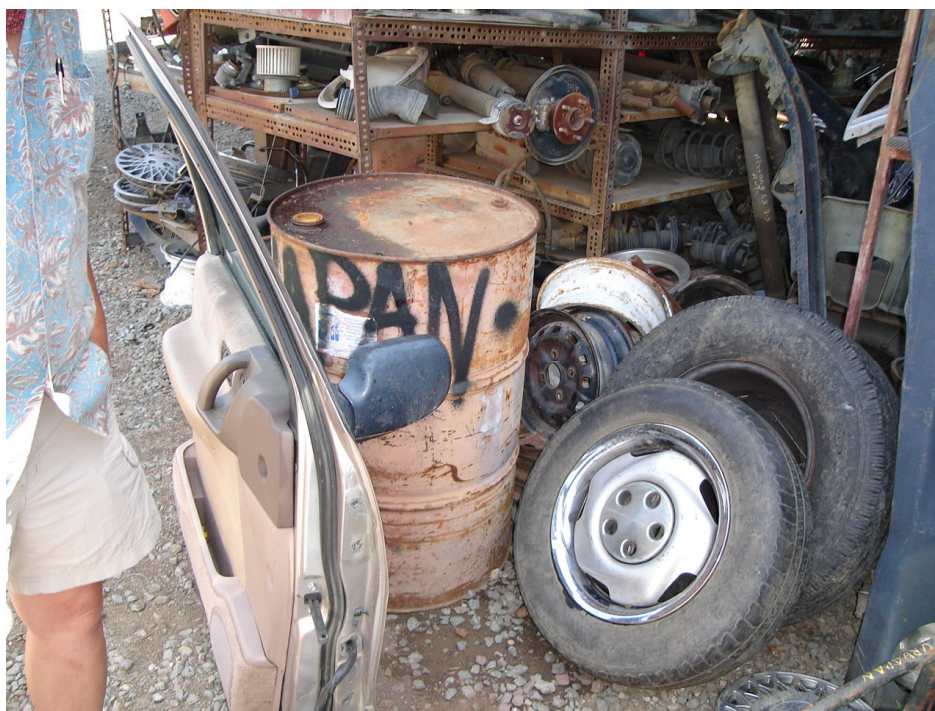
An empty, unlabeled 55-gallon drum was observed on the ground surface adjacent to an automobile parts storage area at Uruapan Auto Dismantling. Evidence of stains or leaks was not observed on the ground surface in the vicinity of the drum.

**Photograph #10**  
**View of empty unlabeled drum at Uruapan Auto Dismantling.**

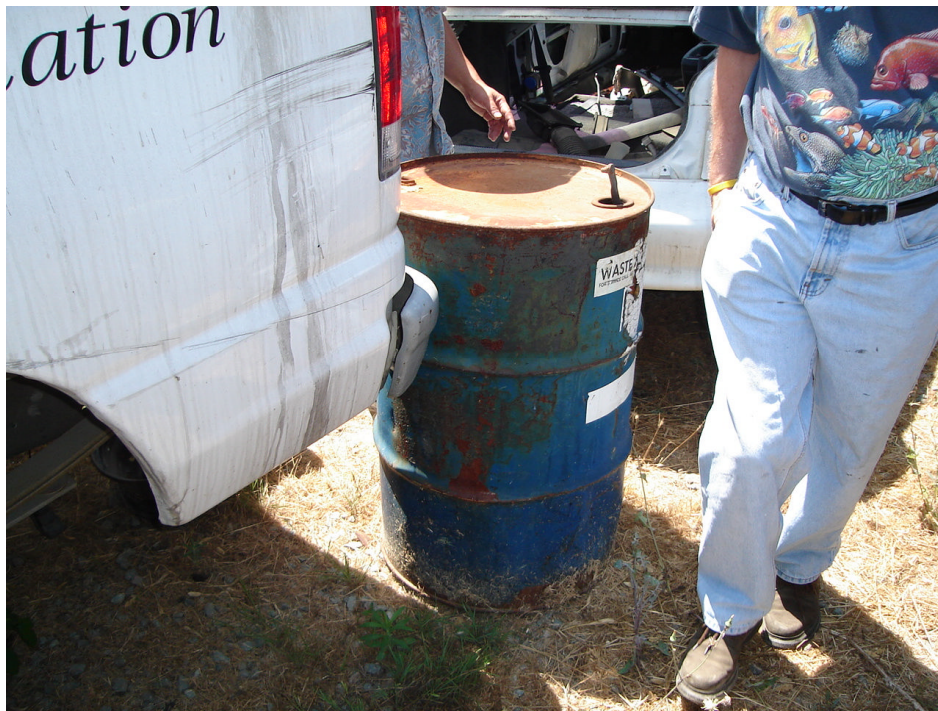
**Photograph #11**

**Fifty-five gallon drum labeled waste oil on gravel surface in center of Uruapan Auto Dismantling.**

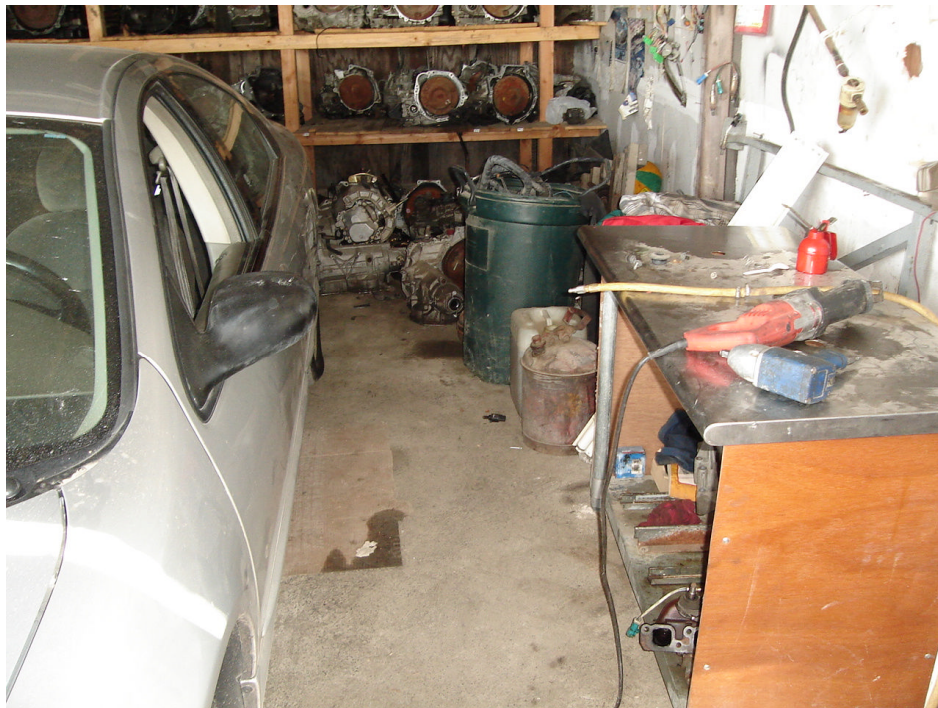
**Photograph #14**  
**View of two gasoline storage containers, at right, on concrete floor of transmission shop at Metro Auto Dismantling.**

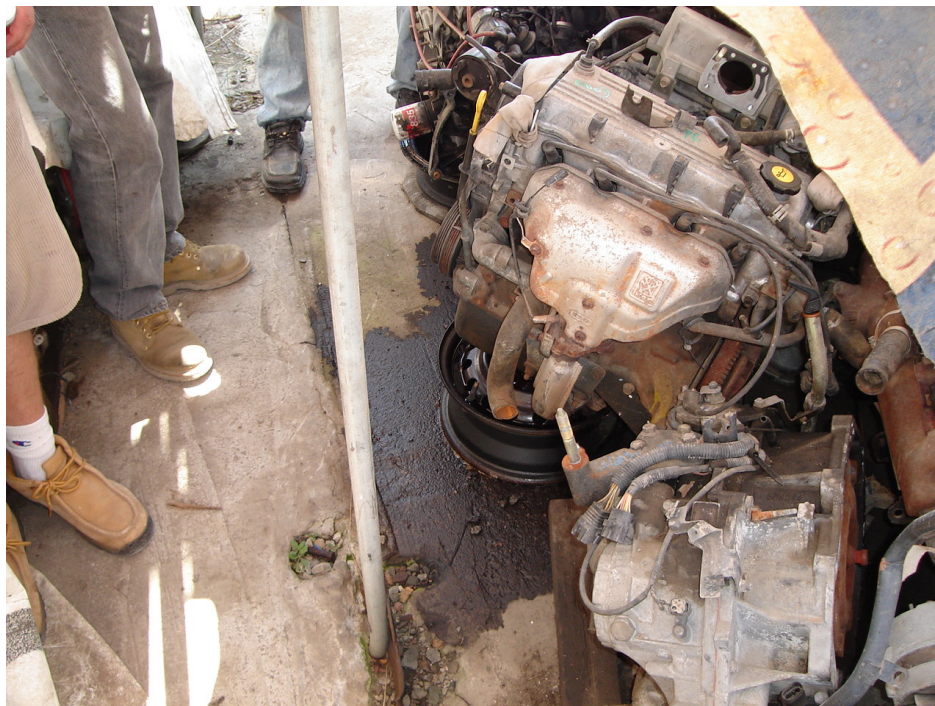
A large oily stain was observed on the concrete pavement underneath an automobile engine in the engine storage area at Atlantic Auto Dismantling. Because of the large number of engines stored in this area, it was not possible to assess the size of the stain. The stain extended into a crack observed where two sections of concrete met in this area.

**Photograph #17**  
**View of oily stain on concrete in engine storage area at Atlantic Auto Dismantling.**

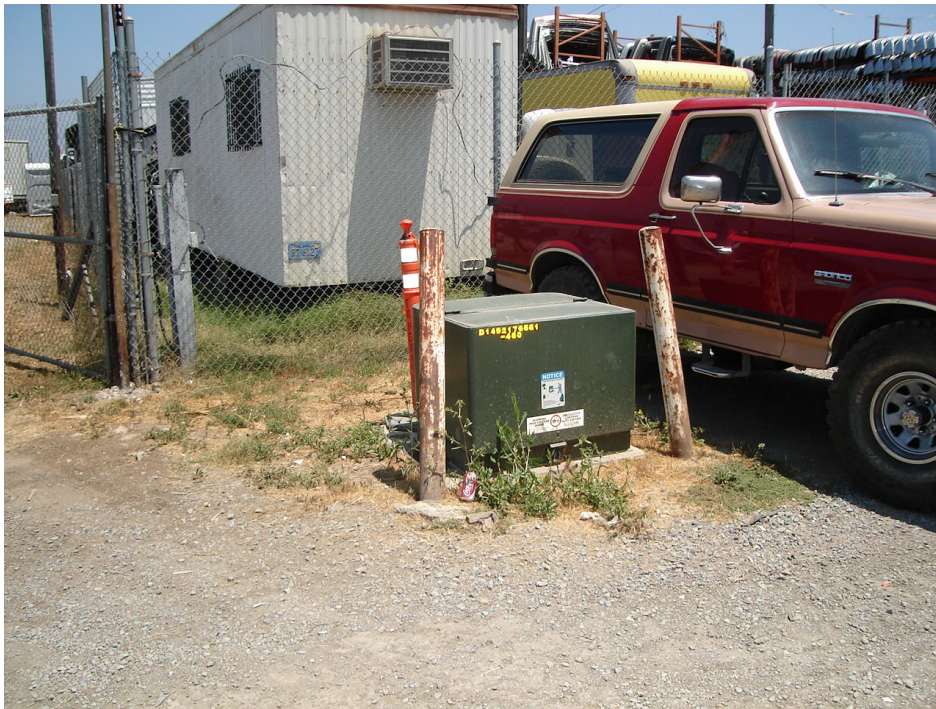
**Photograph #21**  
**View of typical pad-mounted transformer at Site (one of four)**  
**located in northwest portion of Site on north side of central road.**

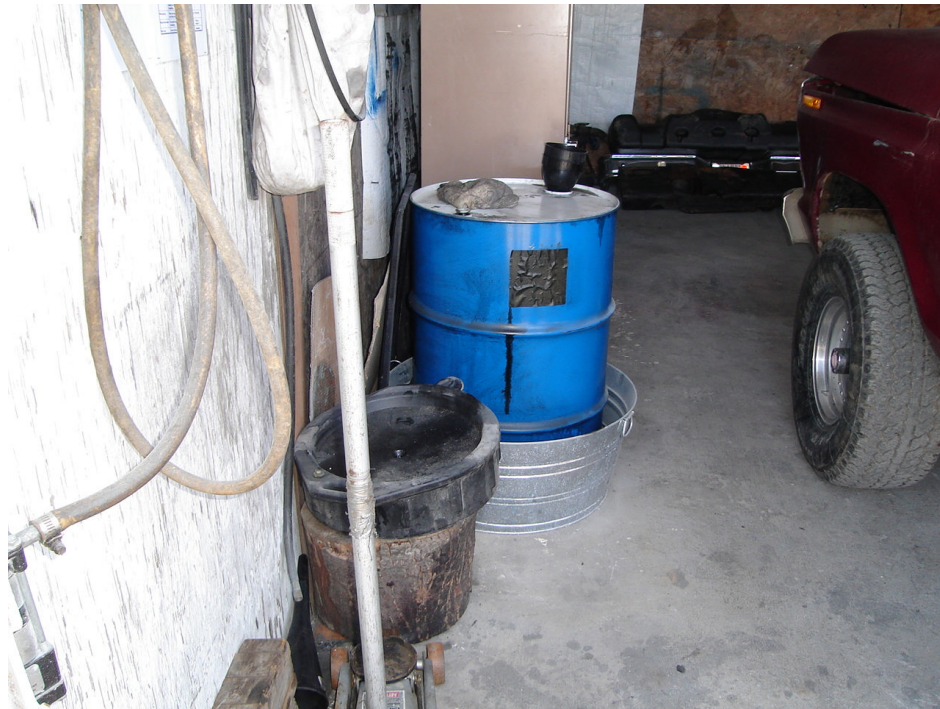
**Photograph #23**  
**View of 55-gallon drum containing waste oil at Cortez Towing.**

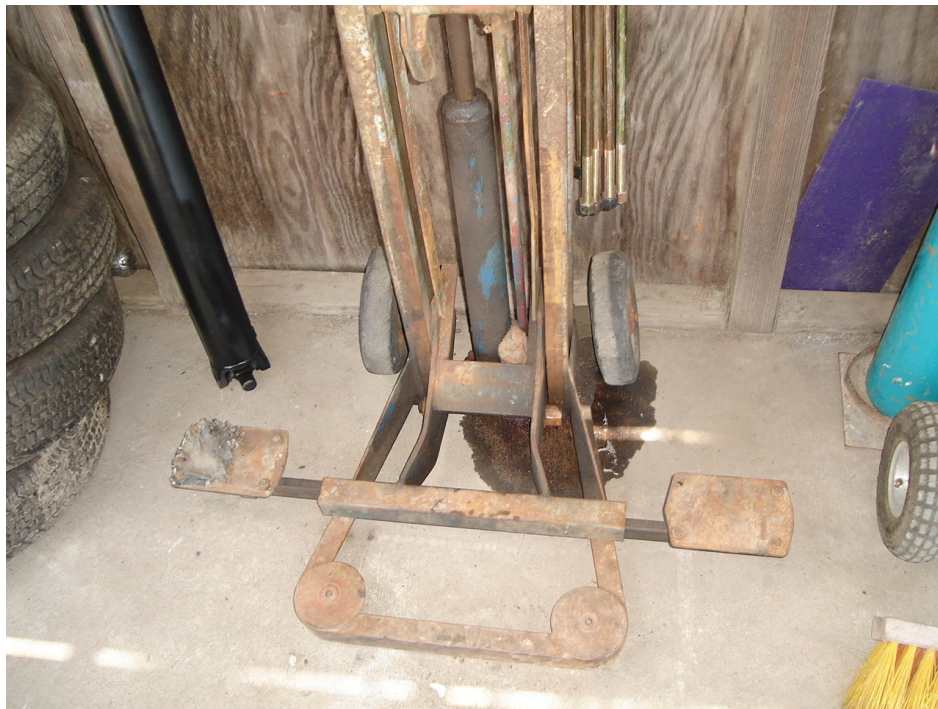
A small oily stain (approximately 1-foot-square) was observed on the concrete floor underneath an automobile jack in the covered automobile maintenance area at Tommy Tucker. The concrete in this area was observed to be intact, with no evidence of significant cracks observed.

**Photograph #26**  
**Minor oily stain on concrete pavement under automobile jack at automobile maintenance area at Tommy Tucker Automobile Storage/Sales.**

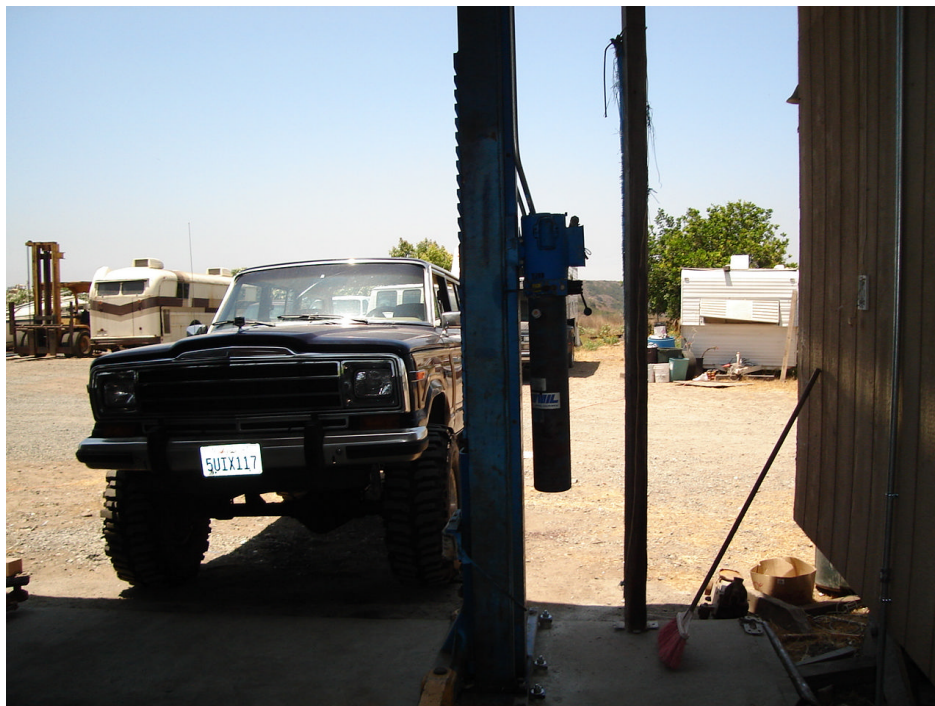
One hydraulic automobile lift was observed in the southwest portion of the Site at Tommy Tucker automobile storage and sales facility. The hydraulic reservoir associated with the lift was observed on the side of the lift. Evidence of stains or releases was not observed in the vicinity of this hydraulic equipment at the time of the site reconnaissance.

**Photograph #27**  
**View of hydraulic reservoir associated with automobile lift in automobile maintenance area at Tommy Tucker Automobile Storage/Sales.**

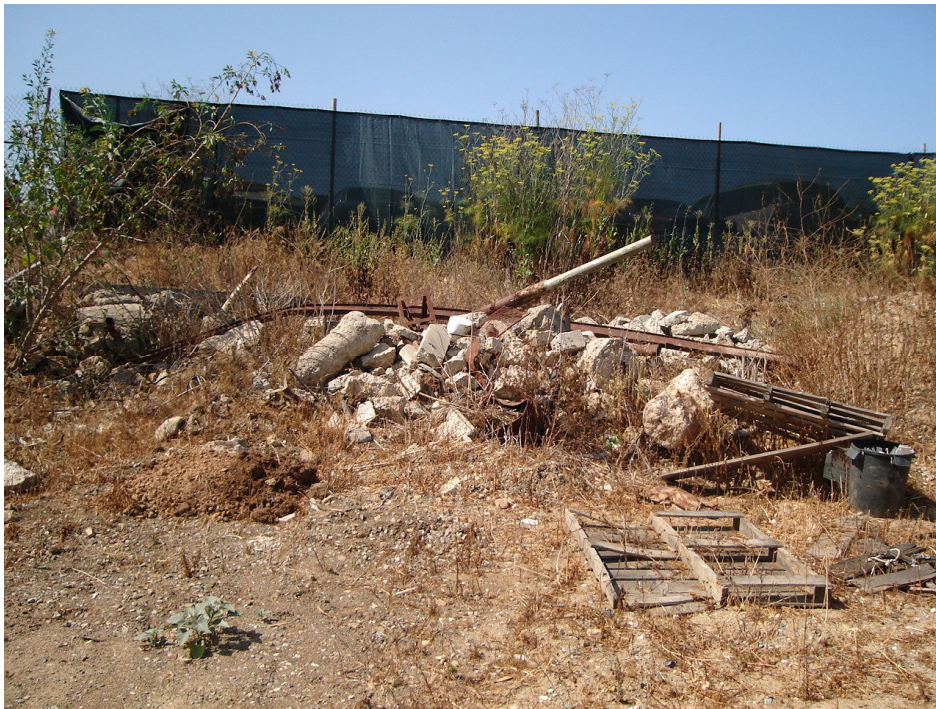
A large pile of construction debris, including pieces of concrete, pipe, and metal support beams, was observed in the northeast corner of the Site at the time of the site reconnaissance. A second area where construction material had been disposed was observed on the hillside east of the unpaved road at the northeast end of the Site. Evidence of hazardous materials or wastes was not observed in the vicinity of these debris piles.

**Photograph #29**  
**View of concrete and construction debris pile in northeast corner of Site.**
