# HELIX WATER DISTRICT

## SIMULATED HYDRANT FLOW TEST

Date: February 12, 2016

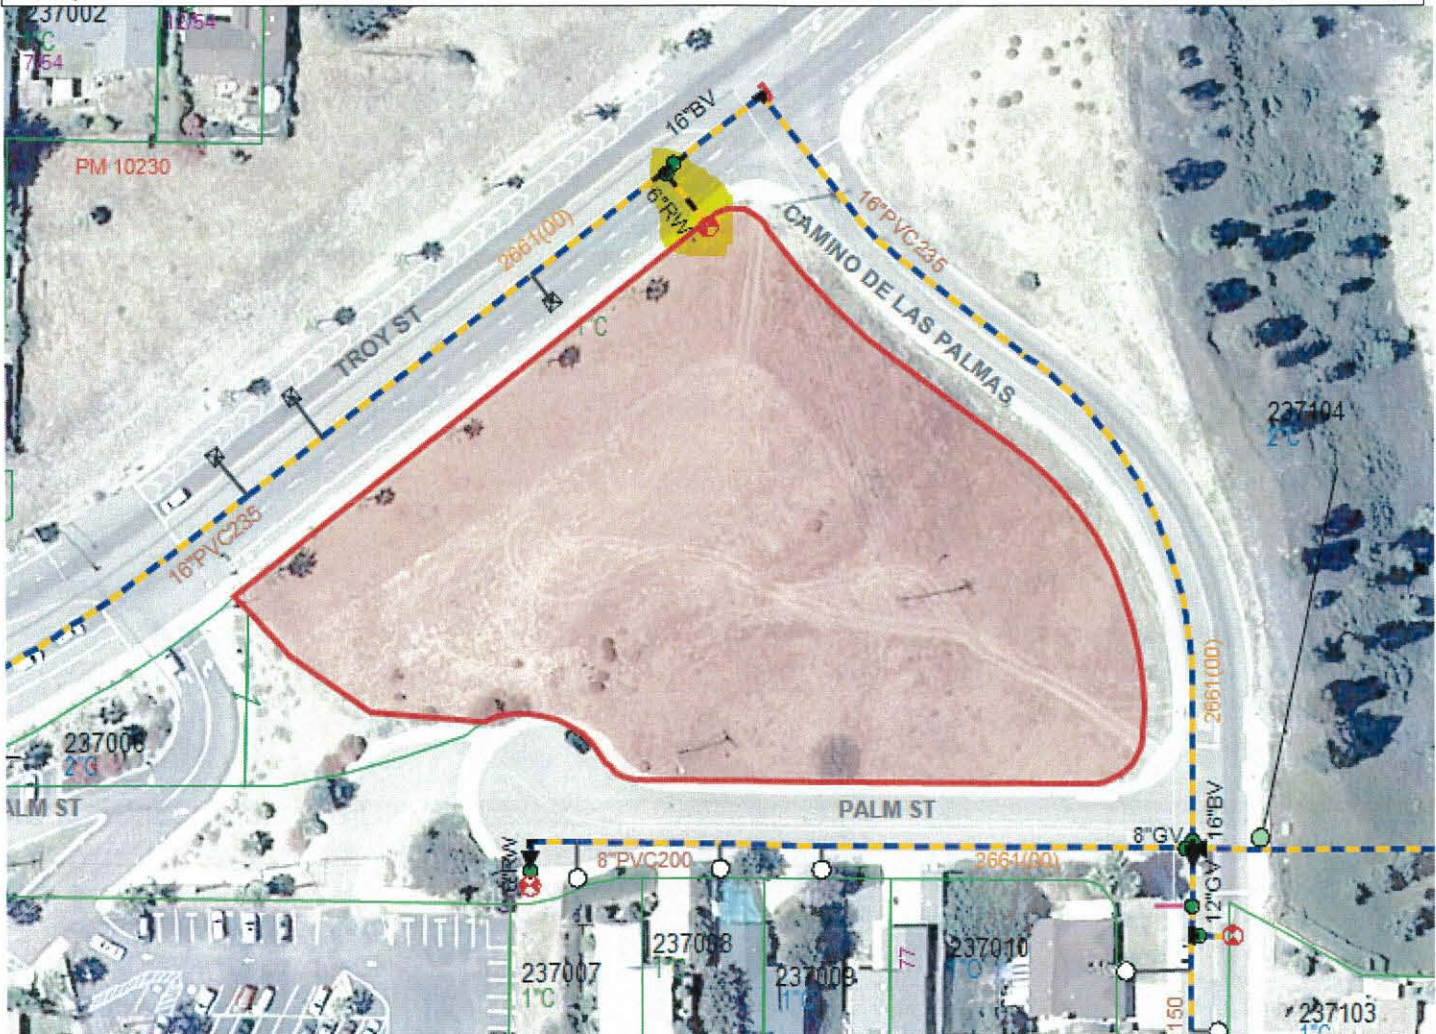
Location	F.H. #	PSI		F.H.	FH Size	Test Orifice Size	Discharge-G.P.M	
		Static	Residual	Model			Observed	20 Lbs.
Troy St. & Camino De Las Palmas, Lemon Grove, CA	501333	65	61	Clow 2.5" x 4"	6"	2.5"	1,015	4,093

**THE FIGURES SHOWN ABOVE WERE GENERATED USING A COMPUTER MODELING PROGRAM BASED ON MAXIMUM DAY DEMAND CONDITIONS.**

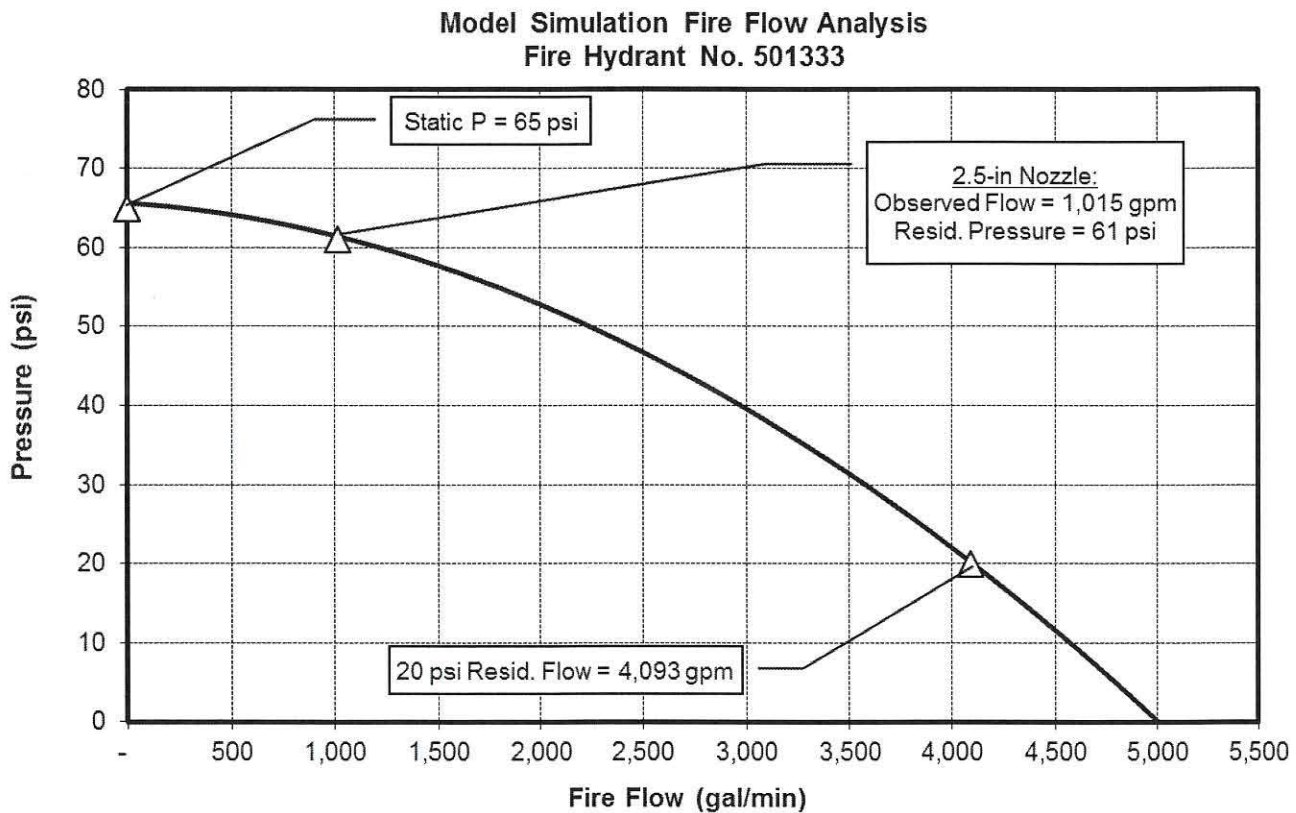
## SIMULATED FIRE HYDRANT FLOW TEST

TESTED: 2/12/2016  
LOCATION: Troy Street @ Camino De Las Palmas, Lemon Grove, CA  
FIRE HYDRANT ID#: 501333

\*This simulated fire flow was calculated on a fire hydrant located at the vicinity of Troy Street and Camino De Las Palmas intersection, Lemon Grove, CA. Helix Water District cannot guarantee a minimum fire flow under all operating conditions at all times and assumes no responsibility for flows less than indicated above, due to but not limited to power outages, earthquakes, acts of nature, system malfunction or failures, and/or maintenance of the facilities. Simulated fire flow analysis performed by Aneld Anub, Associate Engineer.
